Electrical and Electronics

Projects

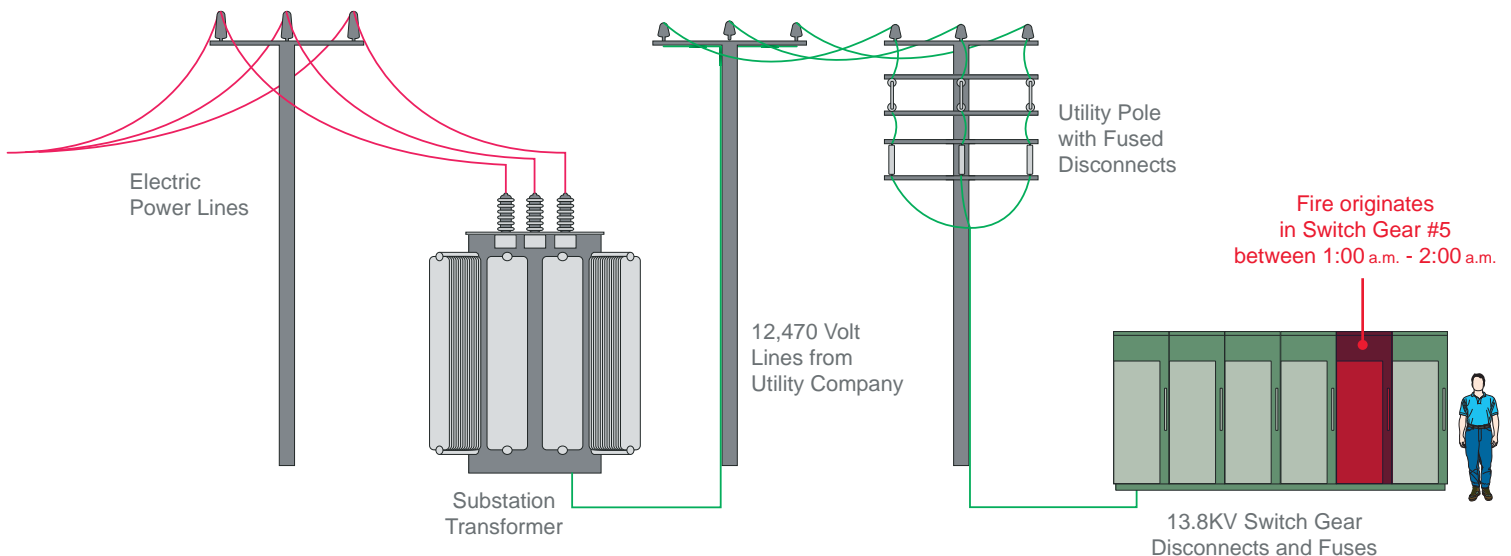
Demonstrative evidence used to show the delivery of power and reduction of power in a switch gear fire.

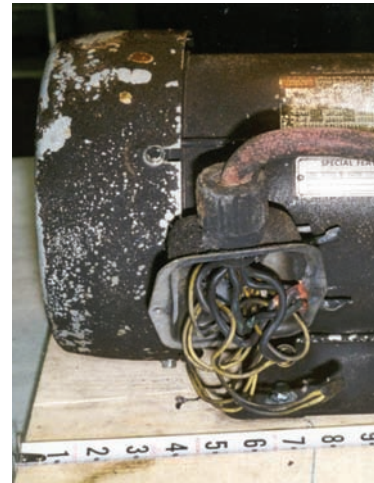
A three-phase electric motor used in a spray booth lost one of its phases in an earlier fire. Despite this fact, the owner placed the motor back into service. One week later, paint mist was ignited by a fault in the motor, which resulted from the earlier degradation of the motor windings. This culminated in a fire, which destroyed the entire building. Packer Engineering determined the owner of the facility had ignored all national and local electrical codes requiring an explosion-proof motor in this application, plus he had continued to use the damaged motor. These two errors, combined with an inadequate ventilation system and poorly designed sprinkler system, led to extensive property loss.

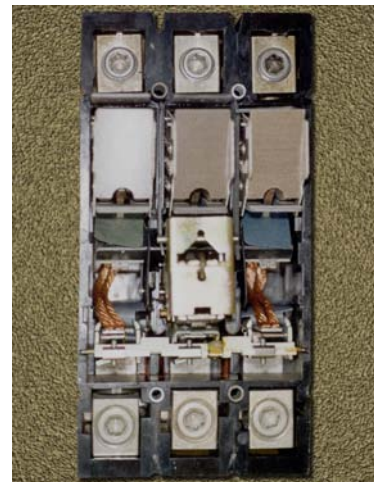
A large restaurant caught fire and burned to the ground. The owner claimed electrical arcing in a piece of conduit started by a circuit breaker malfunction caused the fire. Packer Engineering was hired to investigate the allegation. By simulating energized electrical cables inside of conduit and performing phase-to-ground fault tests, our findings disproved the proposed theory. When simulating their fire hypothesis, the fault did not sustain itself. The physical evidence showed a case of arcing through char was a result of the ongoing fire, and not the cause of the fire.

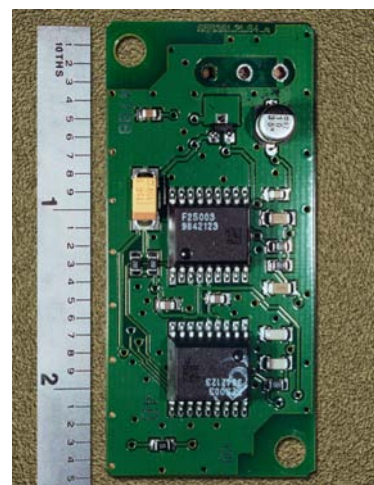
Packer Engineering examined a cross-sectioned tantalum capacitor that had been experiencing intermittent performance, while soldered to a printed circuit board (PCB) assembly for an automotive safety control system. The Scanning Electron Microscope (SEM) revealed the source of the malfunction was the absence of a welded connection internal to the construction of the capacitor. We further determined the manufacturer of the capacitor had changed manufacturing processes to one which was susceptible to this type of failure mode and had inadequate quality control procedures in place. Through testing and process control documents, we established the breadth of the affected manufacturing lots and the time-frame in which the malfunction could be expected to occur.
